## Building Abstract

### Headquarters

### Building 1

**Structure Number:** 1  
**Original Use:** Headquarters for N.W. Branch of the National Home  
**Present Use:** Veteran's Service Offices  
**Construction Date:** 1895  
**Architect:** Unknown  
**Number of Levels:** Three (including basement)  
**Total Area:** 17,600 square feet  
**Plan Shape:** Squared off "C"  
**Basic Construction:** Wood floor joists, masonry bearing walls  
**Uses per Floor:**  
Basement -  
9 Storage rooms, 2 Toilets, 1 Stairway  
First Floor -  
Lobby, 12 Offices, 2 Vaults, Janitors Closet and Toilet Room, 1 Stairway  
Second Floor -  
Bath, 5 Closets, Men's Toilet, 12 Offices, Conference Room, 1 Stairway

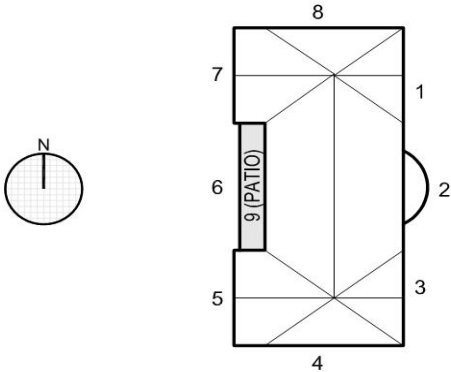
MINOR WALL REPAIRS ARE ALSO REQUIRED AT EXISTING AREA WELLS. MINOR CRACKING OF AREA WELL WALLS WERE NOTED & SHOULD BE ADDRESSED IN THE FUTURE.

THE EXTERIOR ROOF FOR THE BUILDING WAS IN FAIR CONDITION, WITH EXCEPTION OF THE ROOF OVER THE PATIO WHERE STRUCTURAL DEFLECTION HAS CAUSED WARPAGE TO THE ROOF ITSELF. THE ROOFING SHOULD BE ADDRESSED IN THE NEAR FUTURE. IT IS RECOMMENDED THAT THE ROOF BE REMOVED & REBUILT IN ITS ENTIRETY TO PREVEN FURTHER DAMAGE.

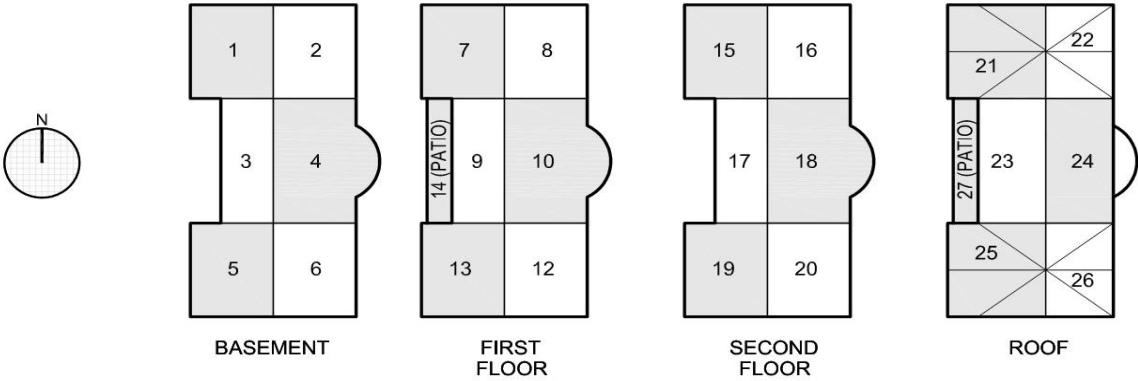
INTERIOR STRUCTURAL SYSTEMS ARE GENERALLY IN 'FAIR' CONDITION, BUT THERE ARE SOME SIGNIFICANT REPAIRS/UPGRADES NEEDED. THERE IS SIGNIFICANT CRACKING IN THE EXISTING FOUNDATION WALL SYSTEMS WHILE MINOR FLOOR CRACKING WAS ALSO PRESENT IN THE BASEMENT CONCRETE FLOOR SLABS. BASEMENT FLOOR HAS UNDERGONE MAJOR MOISTURE DAMAGE CAUSING THE UPHEAVAL OF THE EXISTING WOOD FLOOR DECKING. IT IS RECOMMENDED THAT ALL THESE PROBLEMS BE ADDRESSED IN THE NEAR FUTURE.

EXISTING WOOD FLOOR FRAMING HAS UNDERGONE MINOR DETERIORATION DUE TO MOISTURE PROBLEMS. IT IS RECOMMENDED THAT THE DAMAGED WOOD FLOOR FRAMING BE REFRESHED IN THE NEAR FUTURE TO PREVENT FURTHER DETERIORATION & DAMAGE.
